An illustrated introduction to the medieval  
archaeology of Dungarvan, Co. Waterford

by Dave Pollock

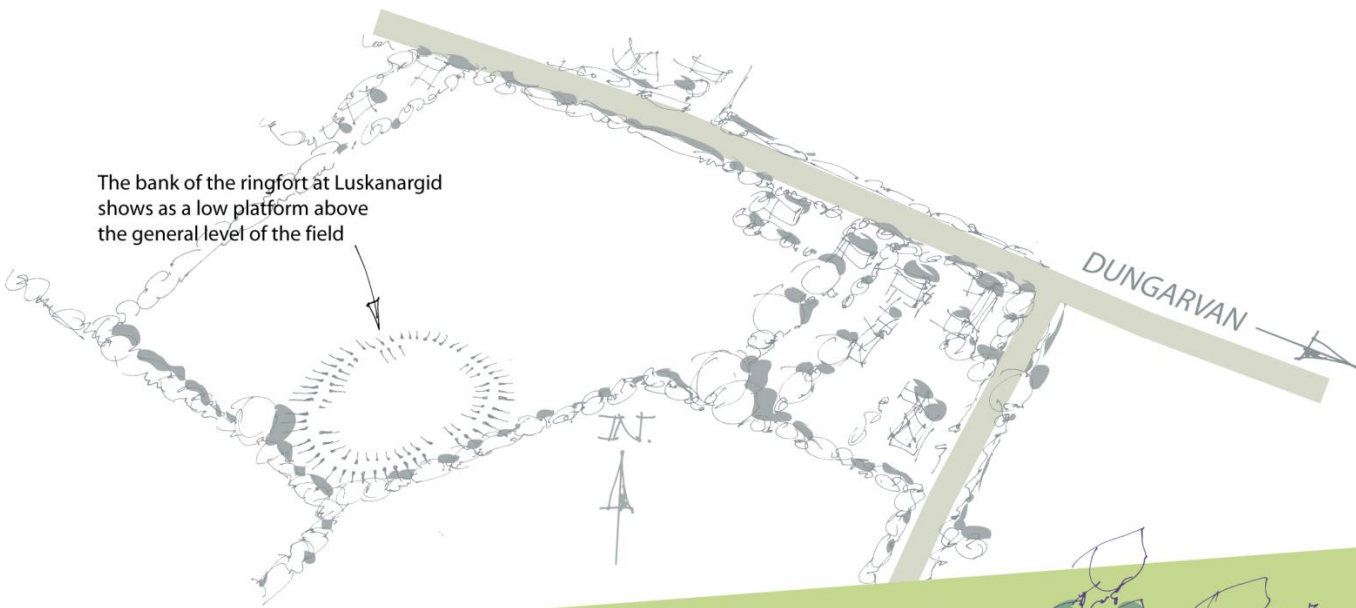
The bank of the ringfort at Luskanargid shows as a low platform above the general level of the field

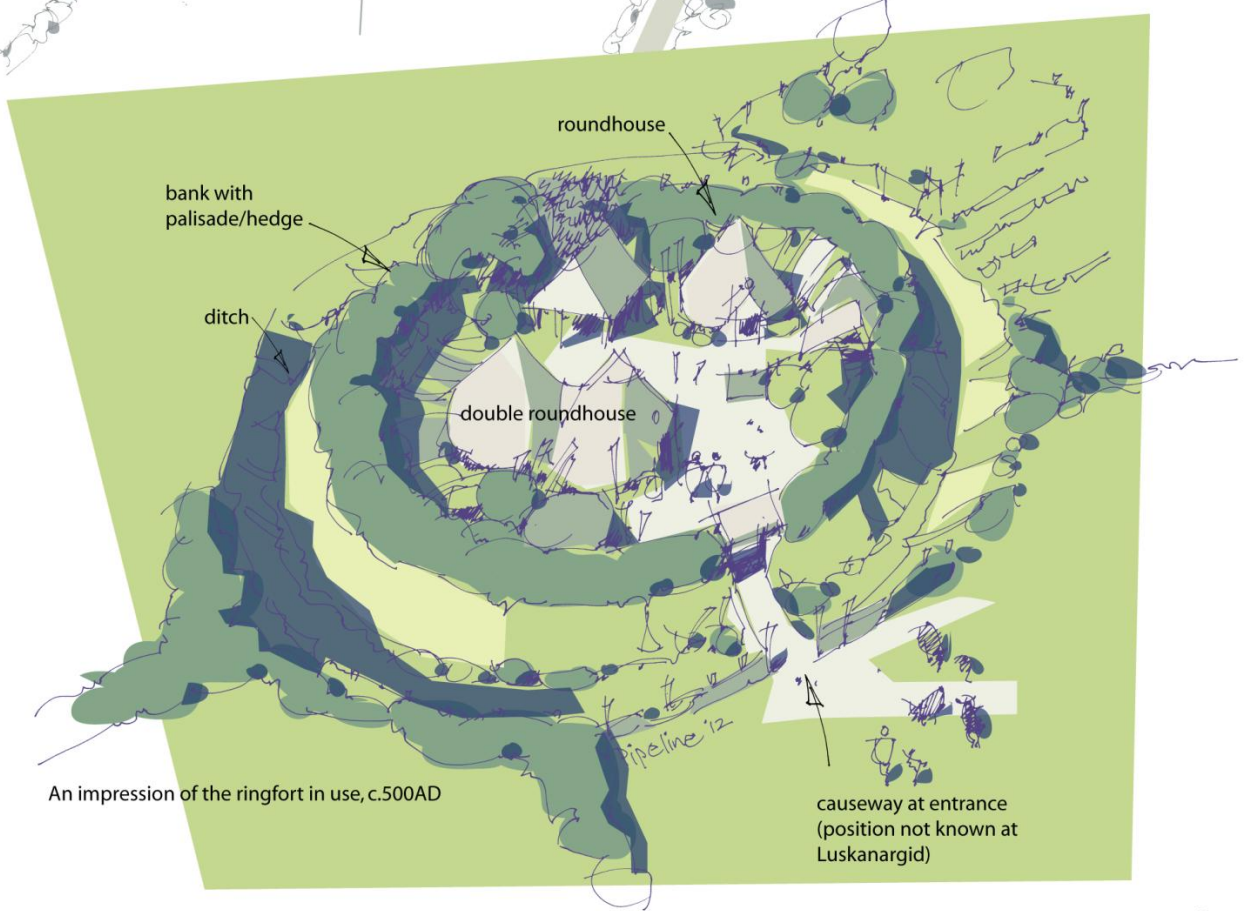
An impression of the ringfort in use, c.500AD

causeway at entrance  
(position not known at  
Luskanargid)

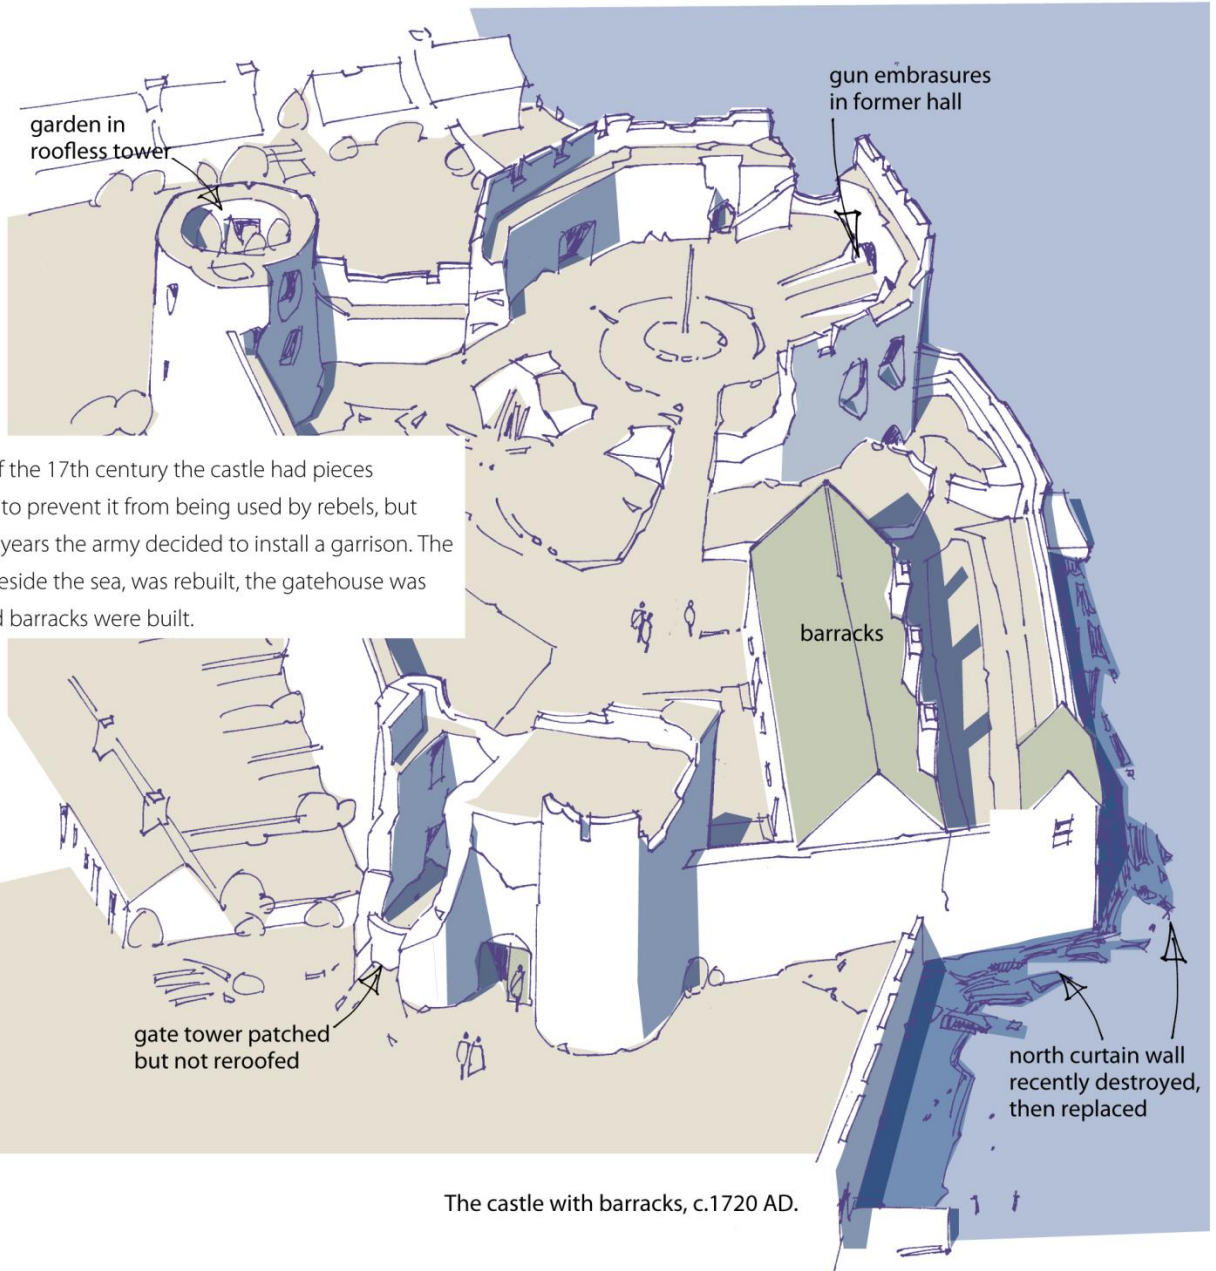
At the end of the 17th century the castle had pieces demolished, to prevent it from being used by rebels, but within a few years the army decided to install a garrison. The north wall, beside the sea, was rebuilt, the gatehouse was patched, and barracks were built.

The castle with barracks, c.1720 AD.
