RIBA STAGE 2 REPORT

# 343 - INCHREE BARN

Project - Inchree Barn

Client - Nether Lochaber Community Association

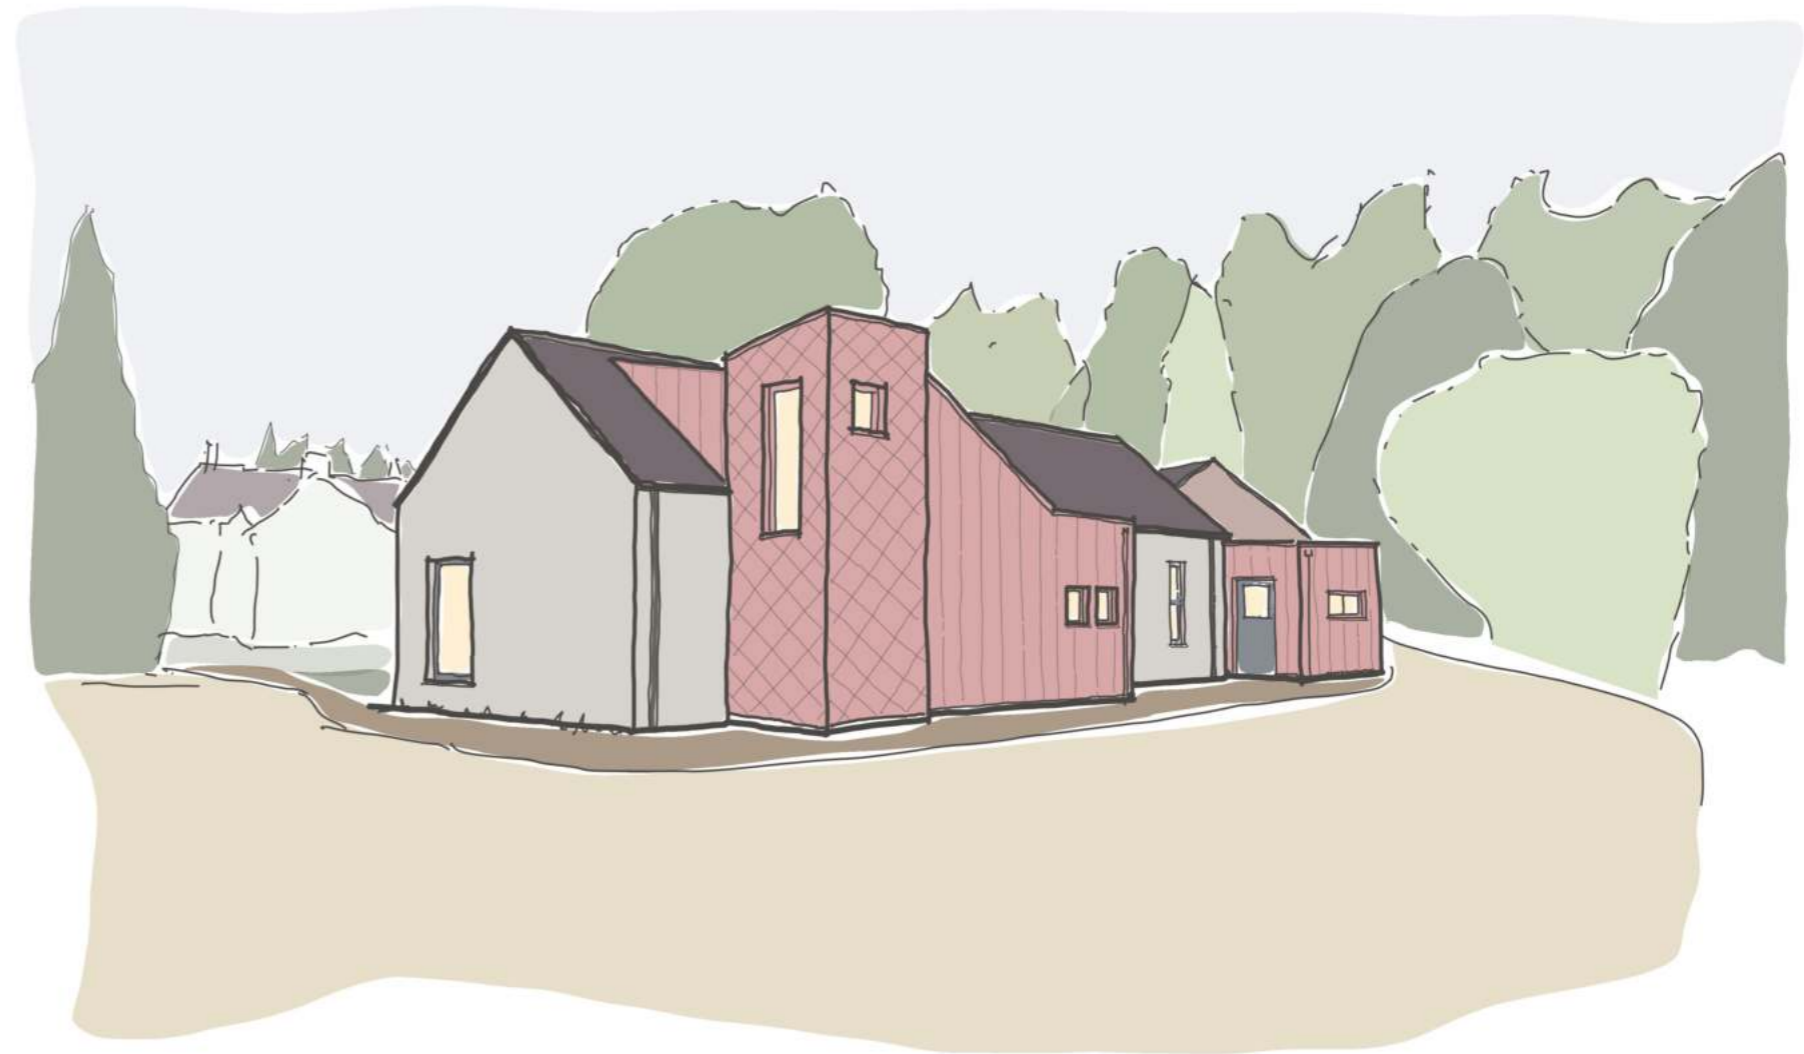
Further development looking at breaking down the mass of the extension stair. The sketch also looks at introducing different textures of cladding to help bring detail subtlety to the form. Due to its proximity to the site boundary this element of the building has to be constructed from non-combustible materials, the sketch illustrates both standing seam vertical zinc alongside a square zinc tile cladding. The same materiality is also reflected in the link piece which also has a close proximity to the site boundary.

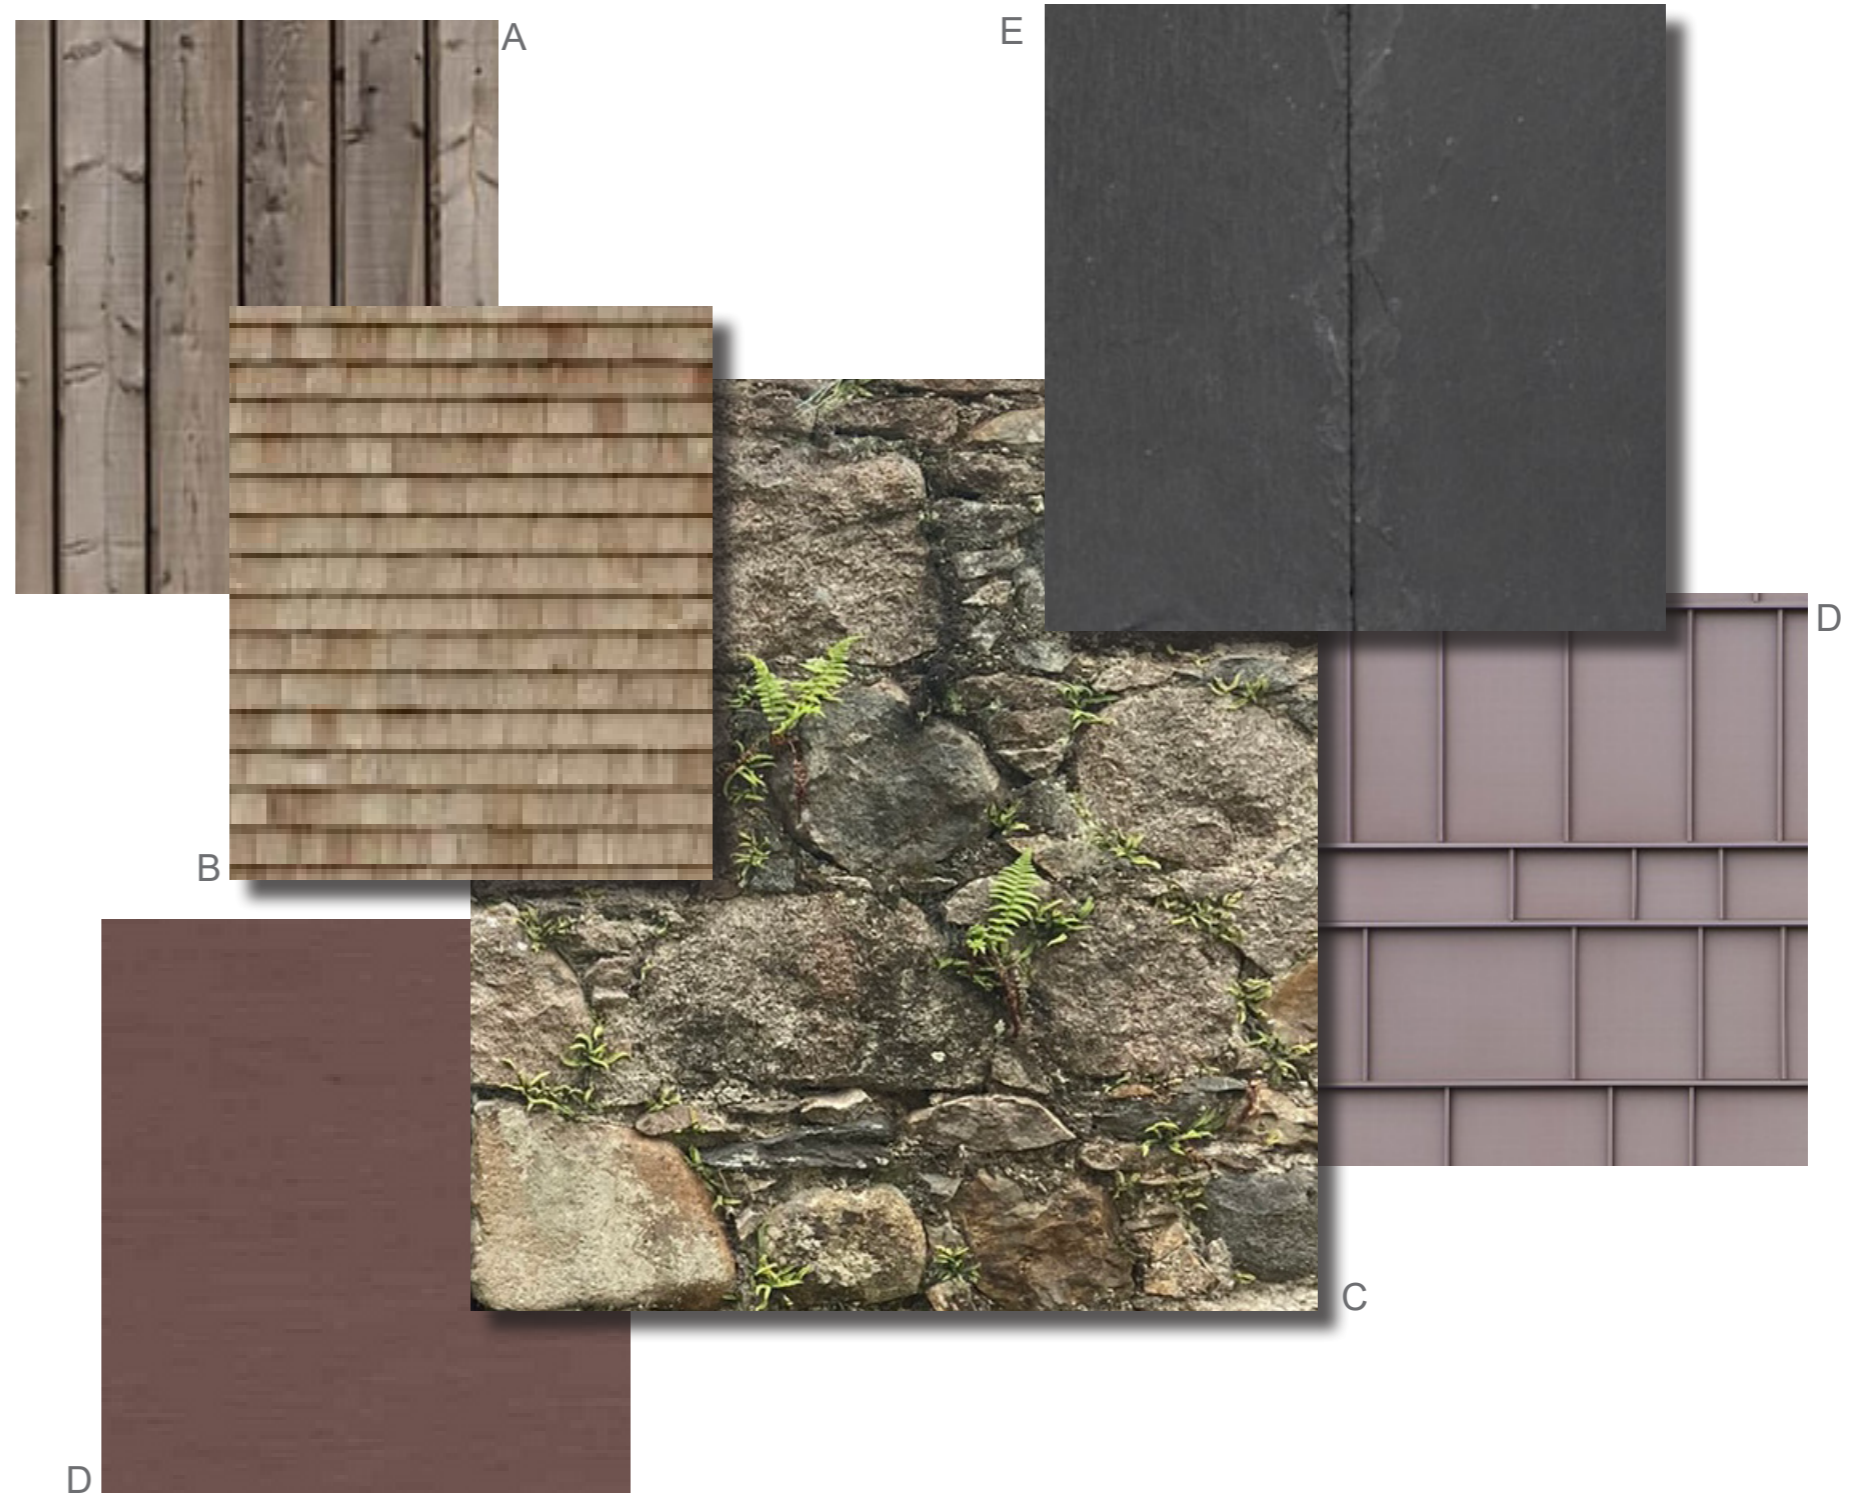
The initial proposals for material selection for the new build external elements draw on the existing character of the barn. The materials chosen look to tonally compliment the barn and ensure that it remains the focus of the cluster of buildings formed. It is proposed that natural materials are used as much as possible, to follow the sustainability strategy as noted on the previous pages and to reflect its rural location.

- A - Scotlarch Timber Cladding
- B - Timber Shingles
- C - Existing Stone Barn
- D - Pigmento Rouge Zinc Cladding
- E - Slate Roof Tiles

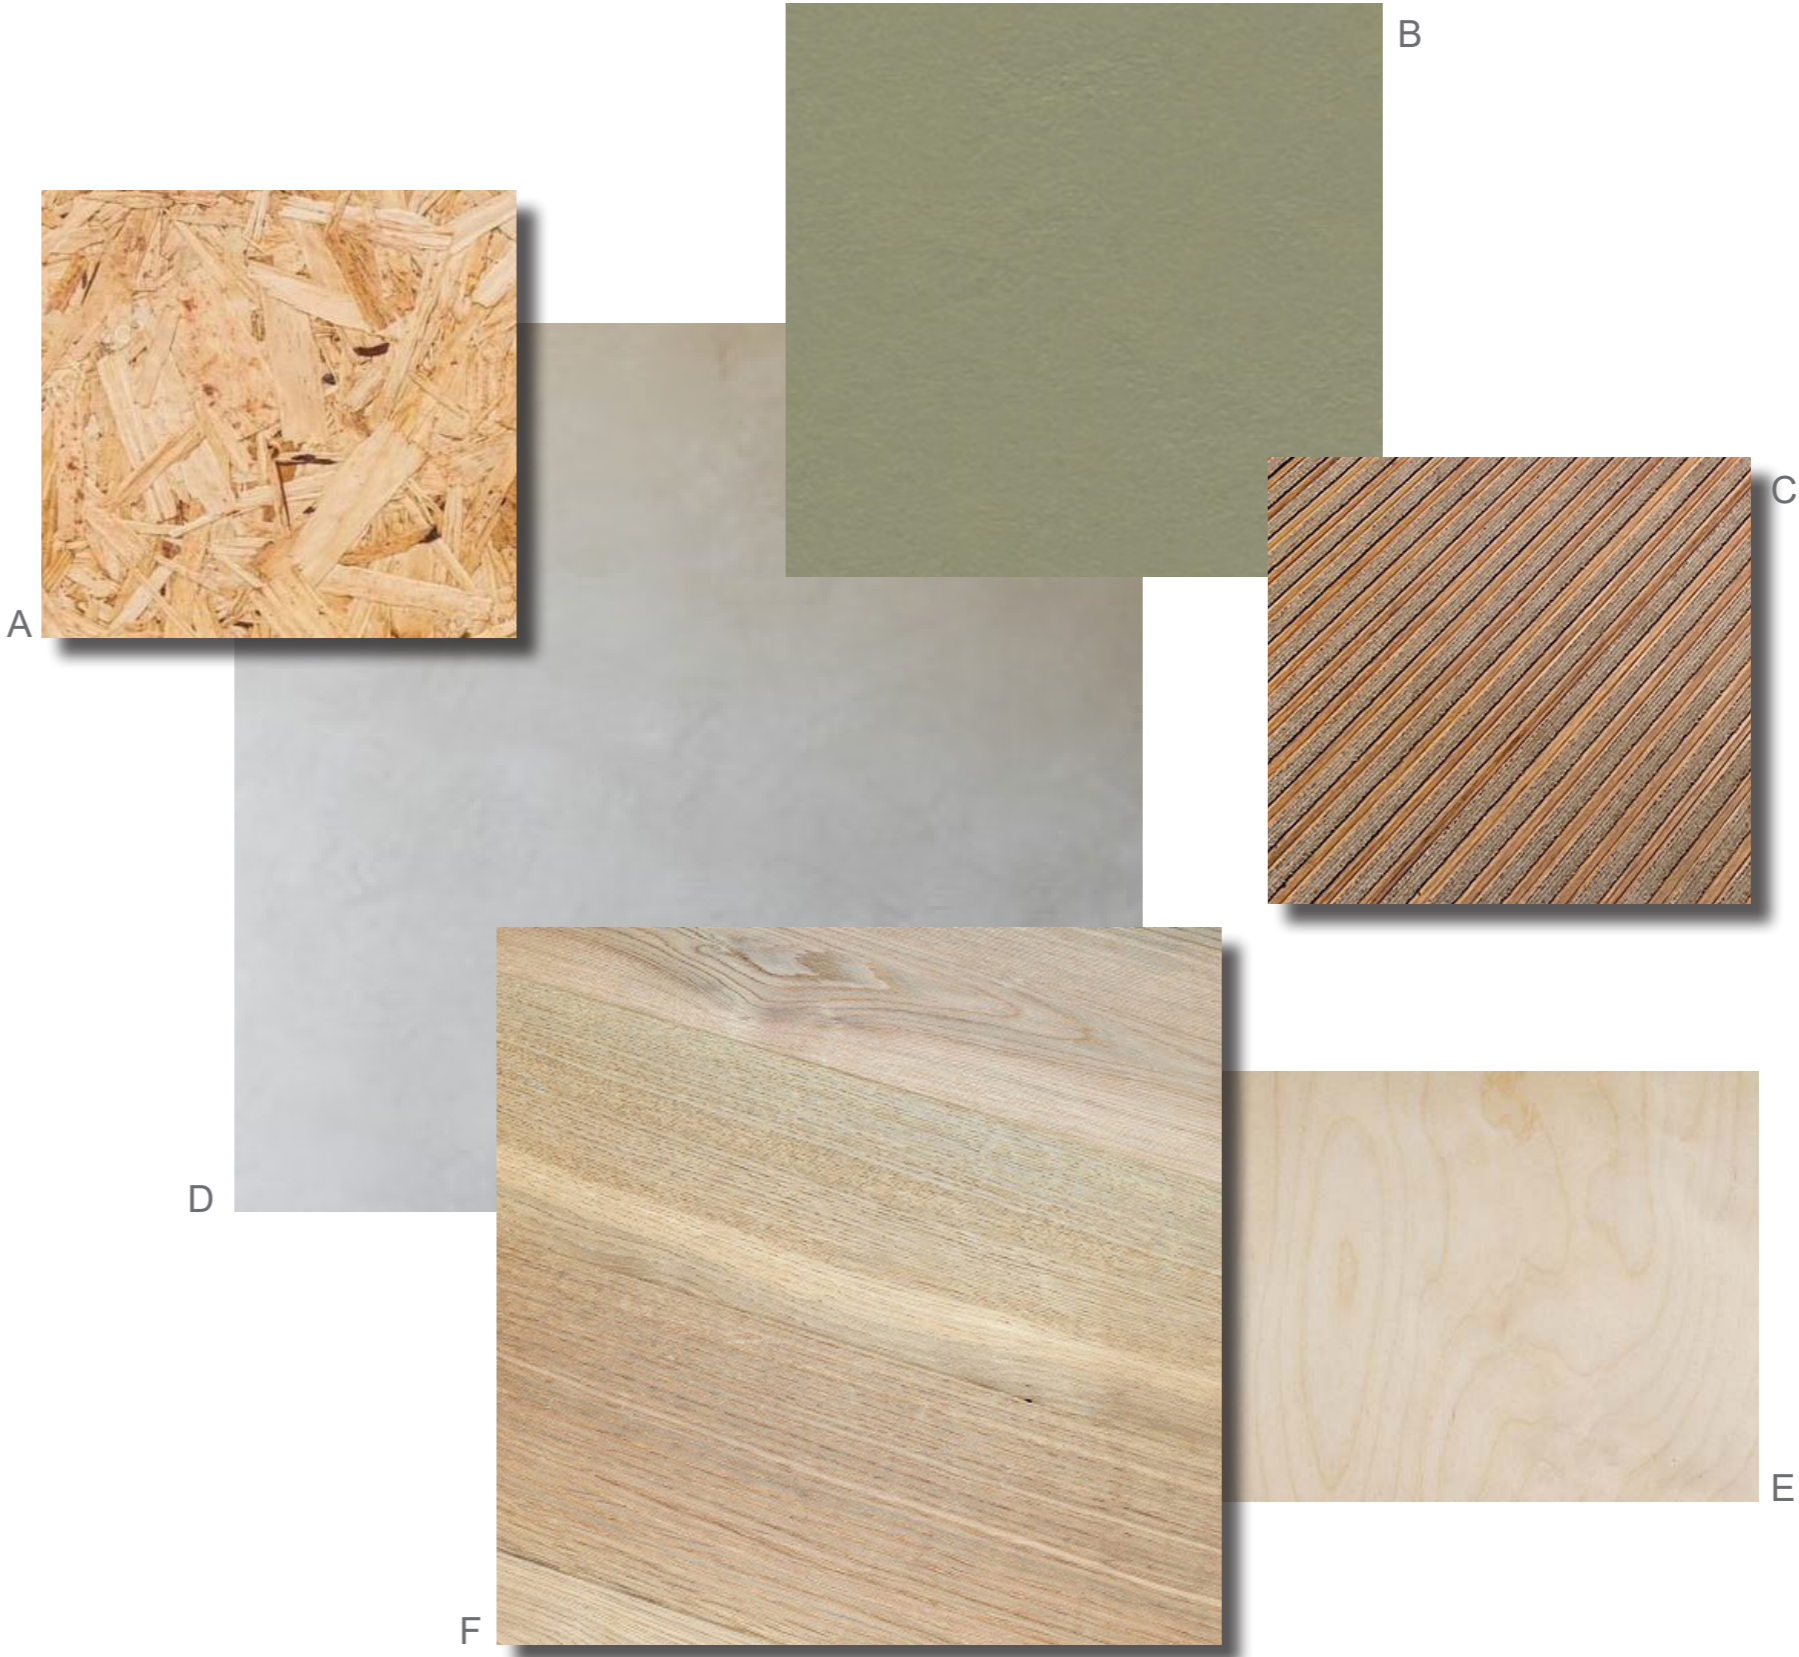
The initial proposals for material selection for the internal finishes aim to continue to celebrate natural materials, taking inspiration from the surrounding natural landscape. The colour palette is neutral with the potential to add some colour accents to bring warmth to the space.

- A - OSB Timber
- B - Natural Tones Vinyl Flooring
- C - Entrance Barrier Matting
- D - Lime Render Wall Finish
- E - Birch Faced Plywood Timber
- F - Oak Flooring

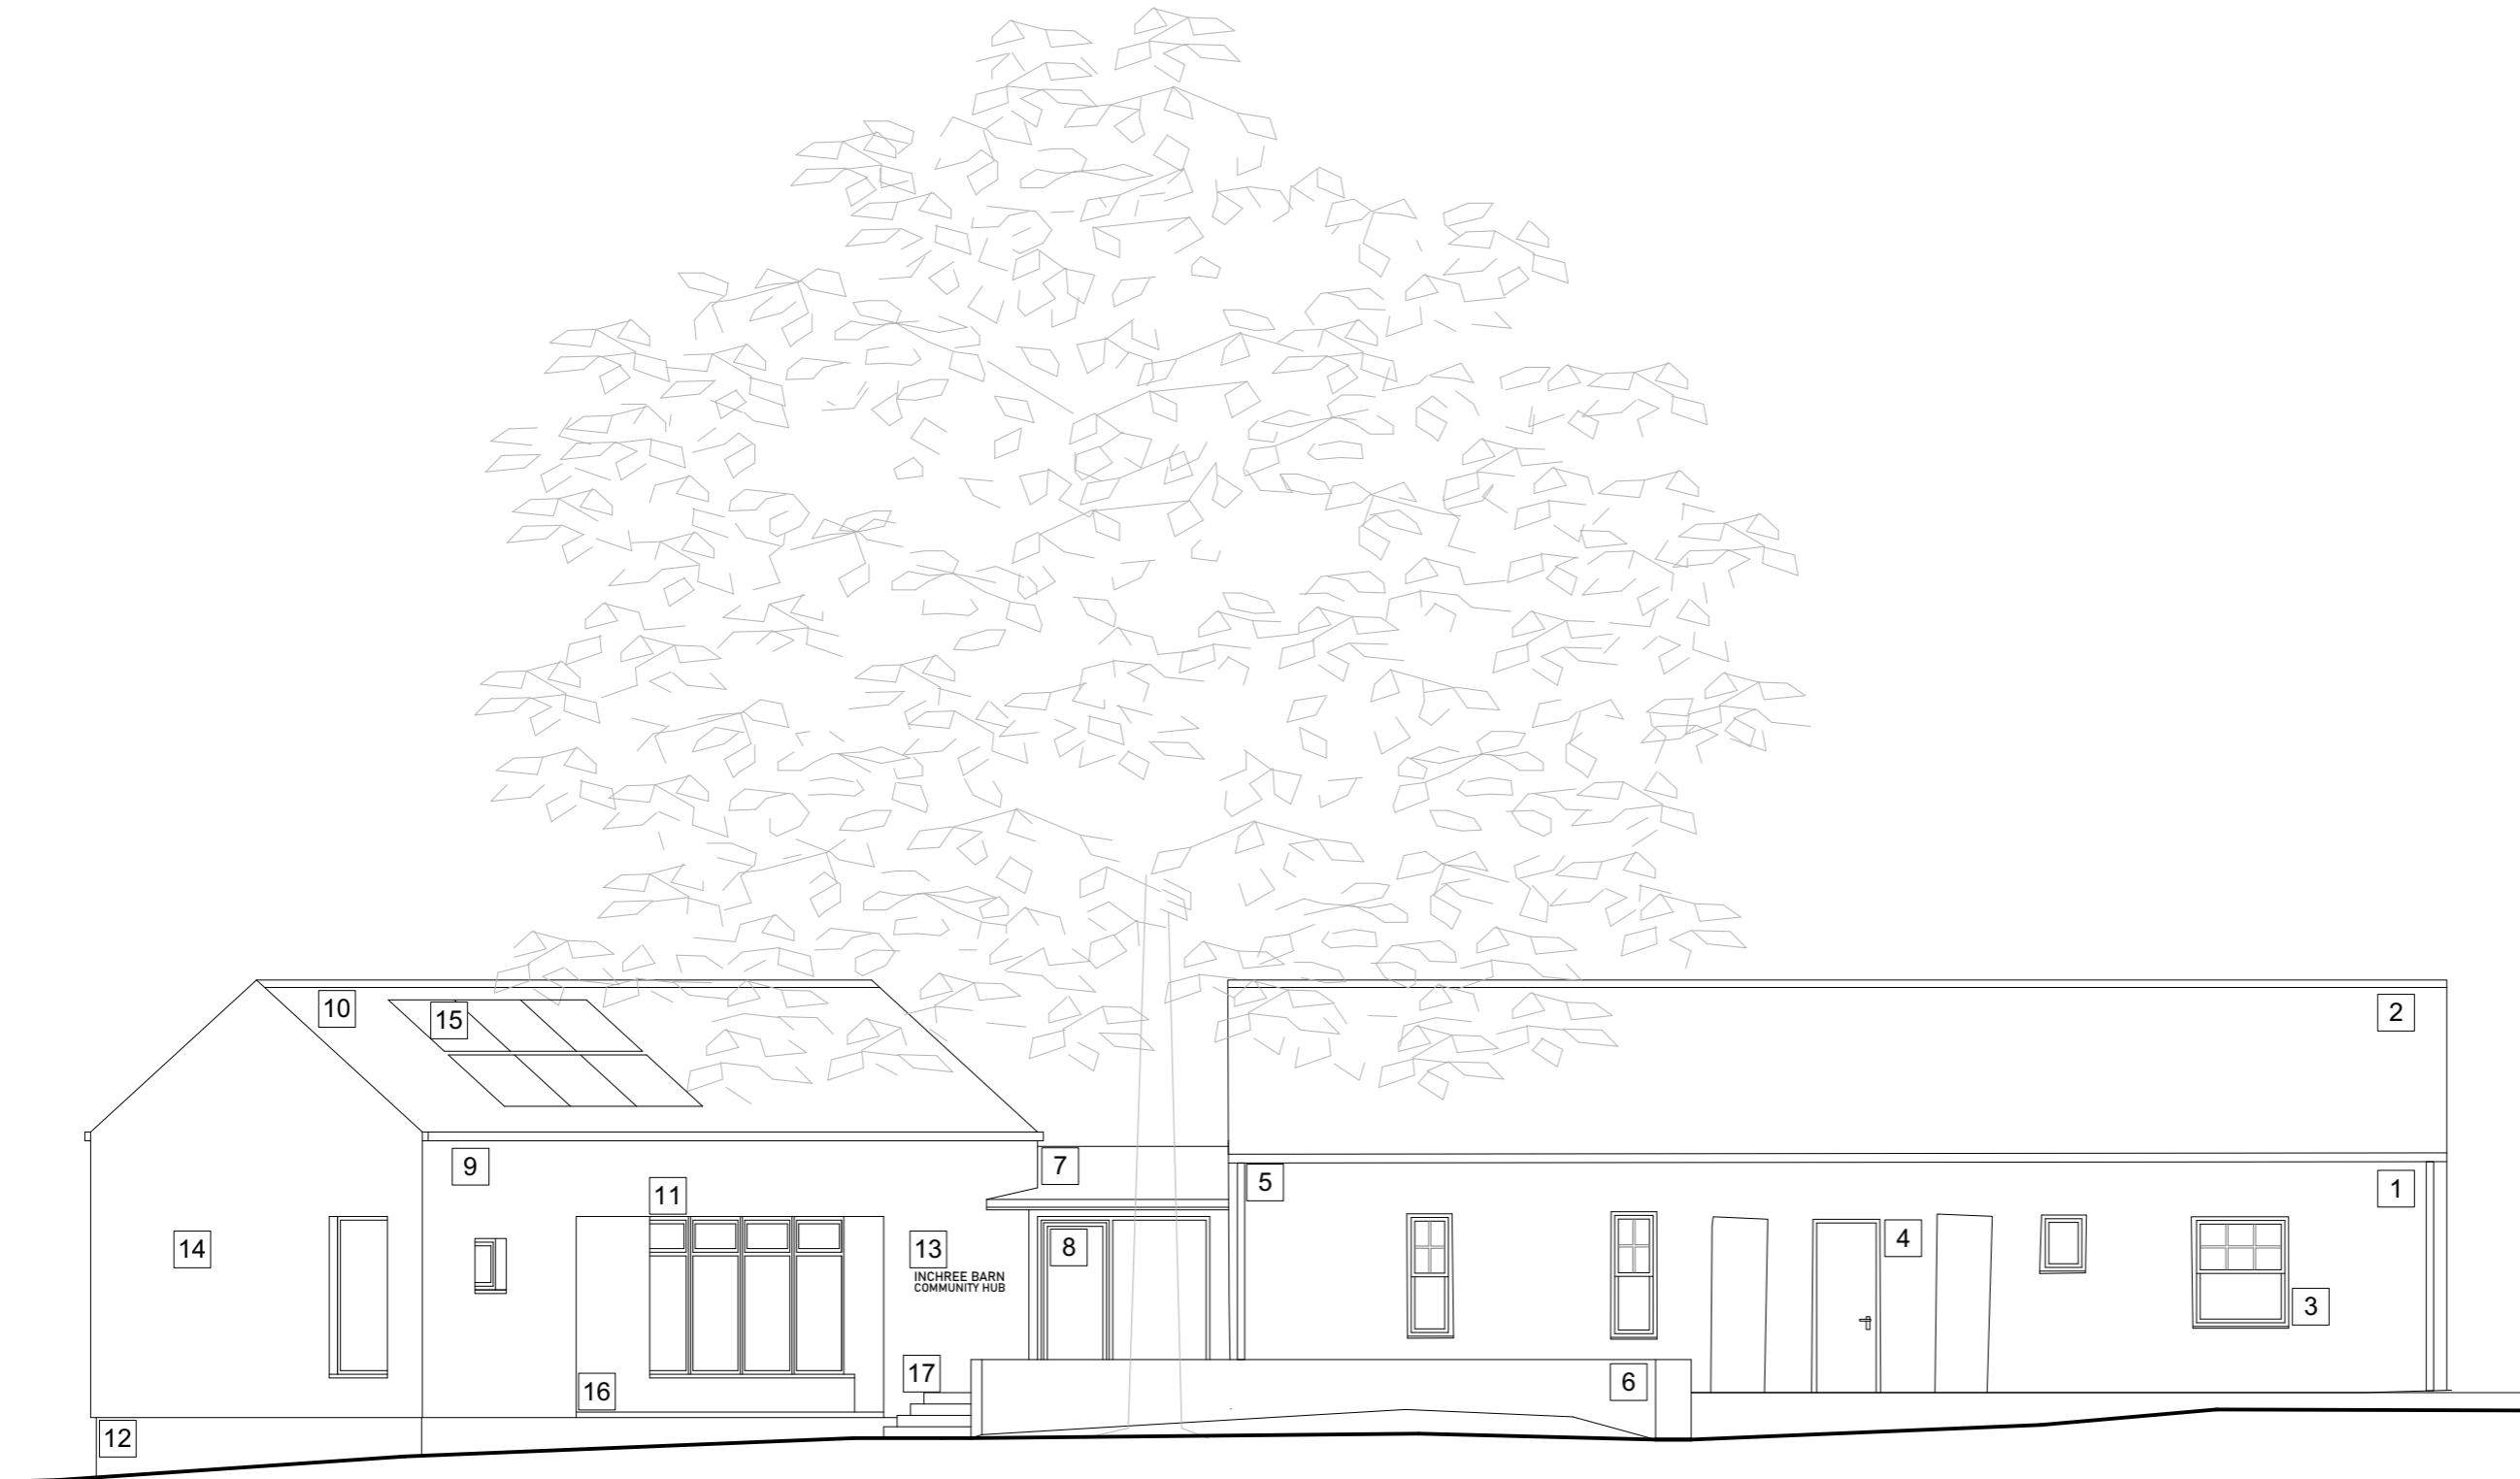
Proposed South Elevation

1. Existing barn - stone walls to be retained and repointed with lime mortar.
2. New slate roof including leadwork flashings.
3. New timber framed double glazed sash and case windows within existing openings.
4. New solid core external timber door within existing opening with lowered cill.
5. Replacement steel rainwater goods.
6. Feature gabion landscaped bench seat filled with stone from demolished lean-to.
7. Low pitch zinc roof over link building
8. Glazed entrance
9. Timber shingle cladding to new barn form building.
10. Slate roof including leadwork flashings.
11. Double glazed aluminium composite windows.
12. Brickwork base to building.
13. Entrance signage.
14. Potential area for community artwork or further signage.
15. Fully integrated PV provision - subject to detailed M&E design.
16. Built in timber bench seat.
17. Precast concrete stair treads to form landscape stair.

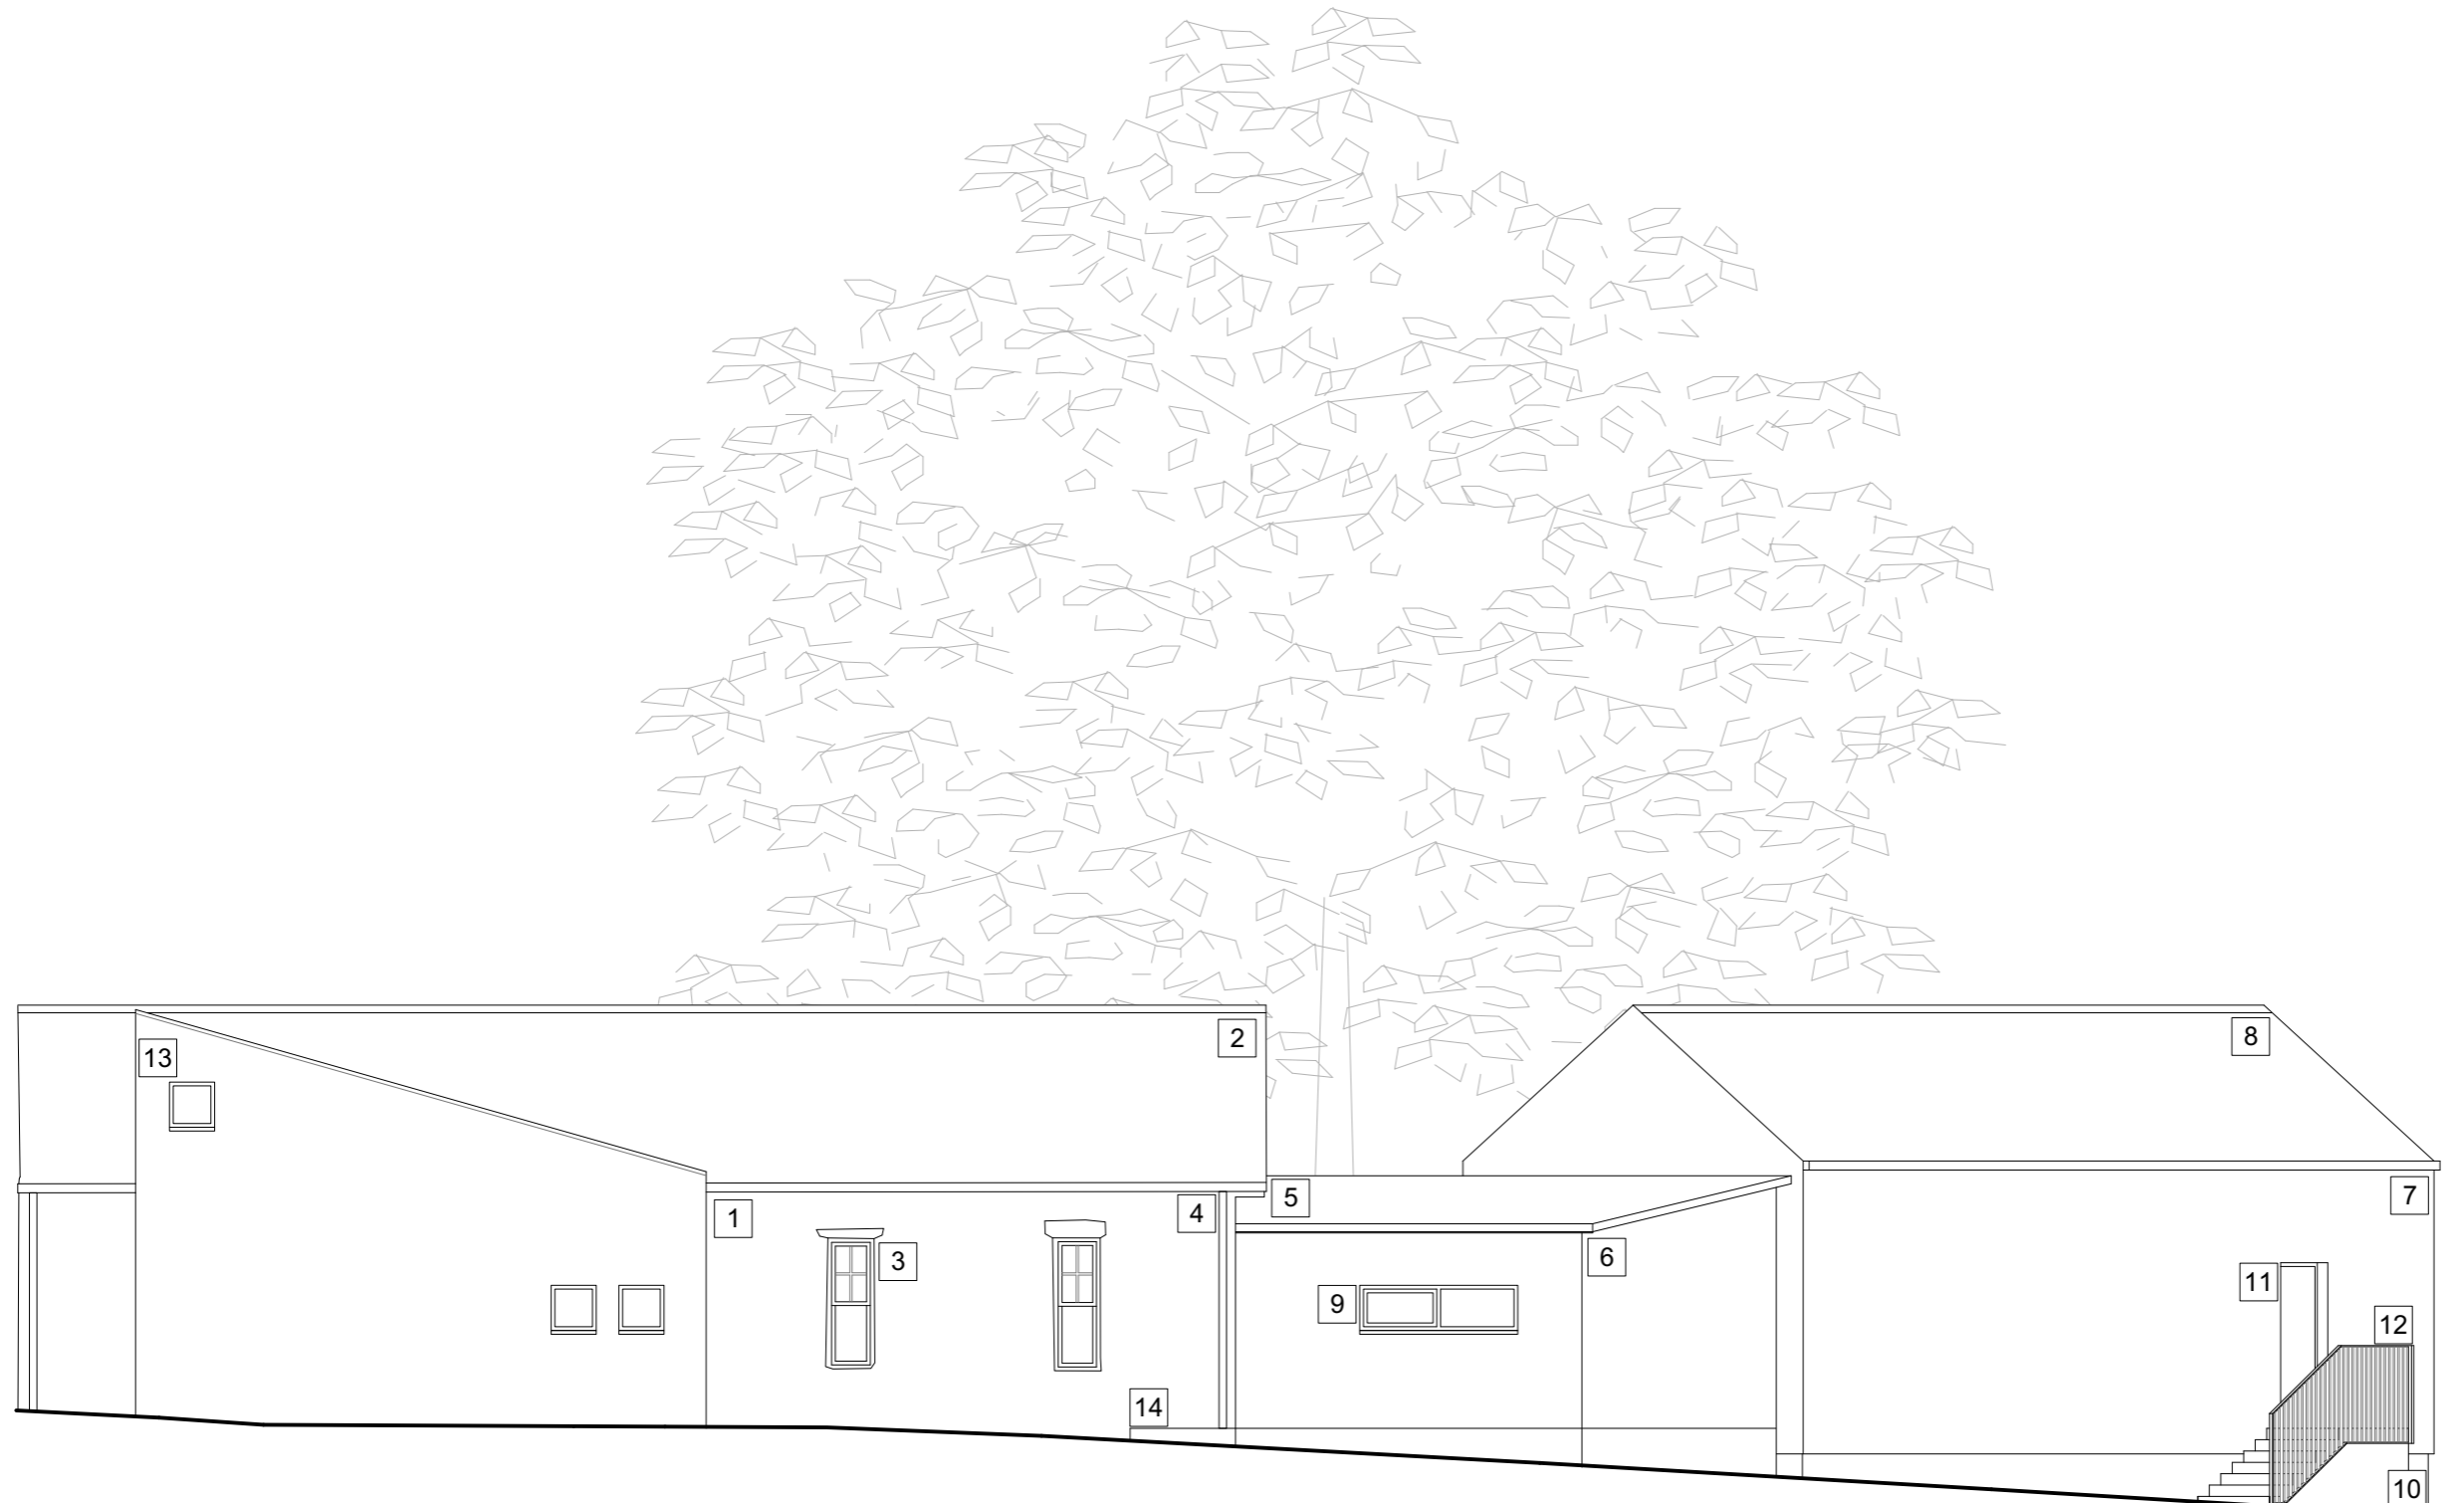
Proposed North Elevation

1. Existing barn - stone walls to be retained and repointed with lime mortar.
2. New slate roof including leadwork flashings.
3. New timber framed double glazed sash and case windows within existing openings.
4. Replacement steel rainwater goods.
5. Low pitch zinc roof over link building.
6. Zinc clad link building
7. Timber shingle cladding to new barn form building.
8. Slate roof including leadwork flashings.
9. Double glazed aluminium composite windows.
10. Brickwork base to building.
11. Steel door to plant room.
12. Brickwork formed access stair with pre-cast concrete treads and landing. Metal railings with integrated handrail.
13. Zinc clad stair enclosure.
14. In-situ concrete step.

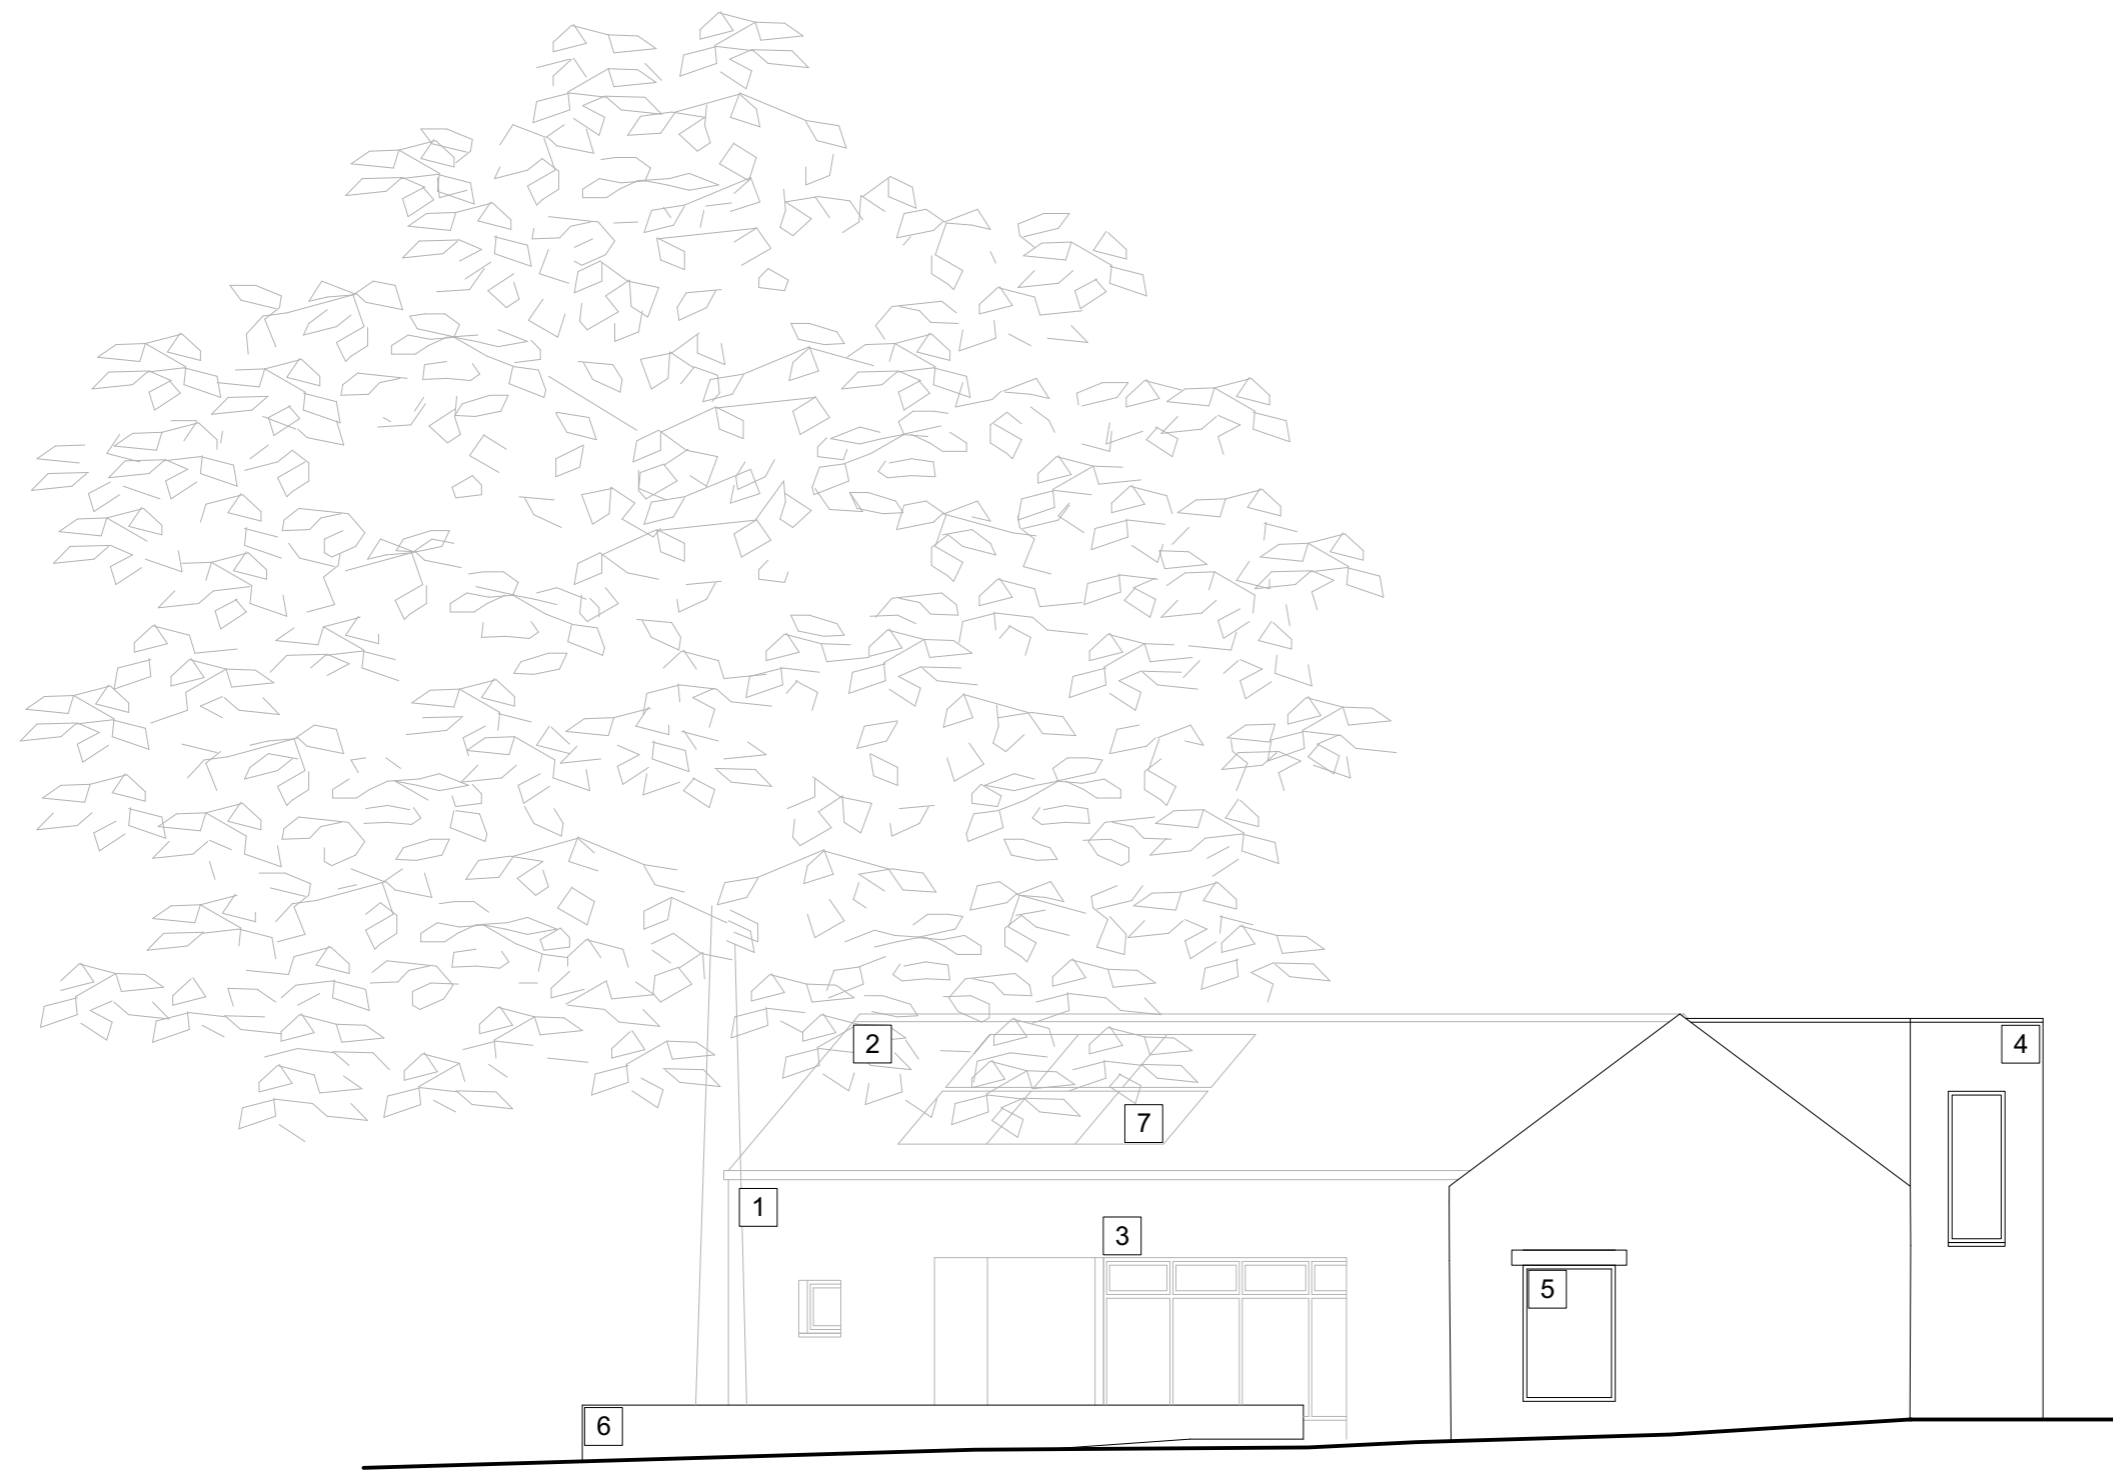
Proposed East Elevation

1. Timber shingle cladding to new barn form building.
2. Slate roof including leadwork flashings.
3. Double glazed aluminium composite windows.
4. Zinc clad stair enclosure.
5. New double glazed aluminium composite window with integrated internal window seat within newly formed opening.
6. Feature gabion landscaped bench seat filled with stone from demolished lean-to.
7. Fully integrated PV provision - subject to detailed M&E design.

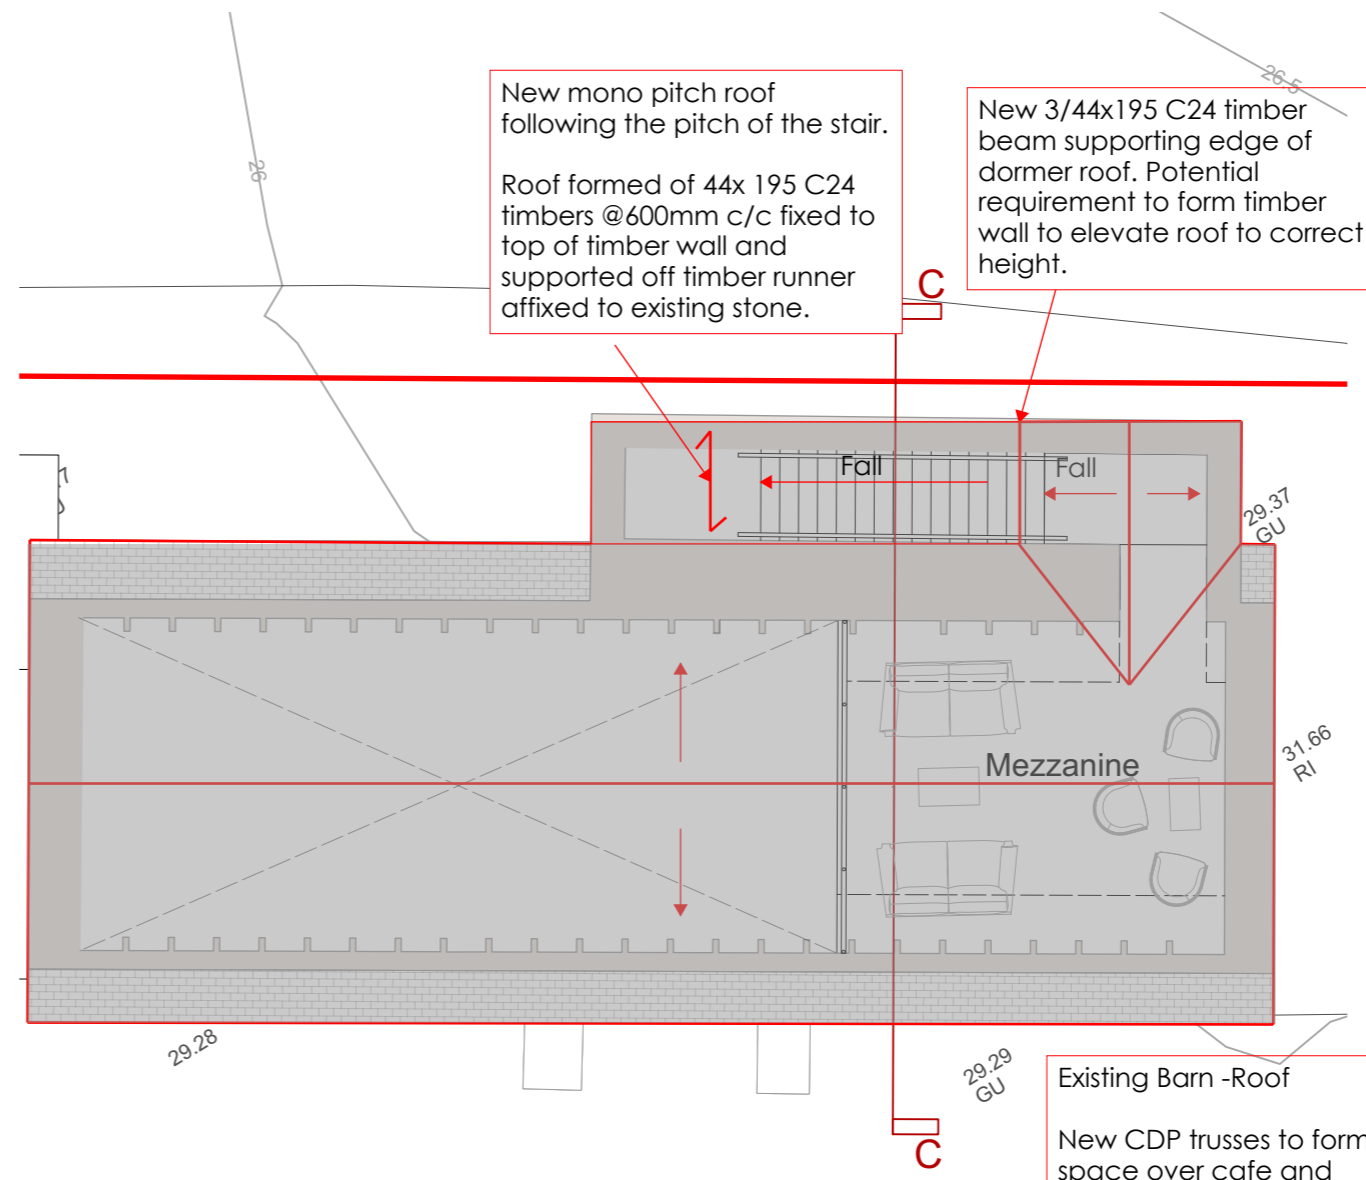
New mono pitch roof following the pitch of the stair.  
Roof formed of 44x 195 C24 timbers @600mm c/c fixed to top of timber wall and supported off timber runner affixed to existing stone.

New 3/44x195 C24 timber beam supporting edge of dormer roof. Potential requirement to form timber wall to elevate roof to correct height.

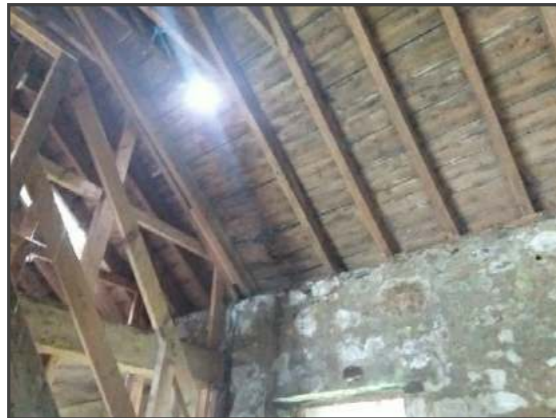
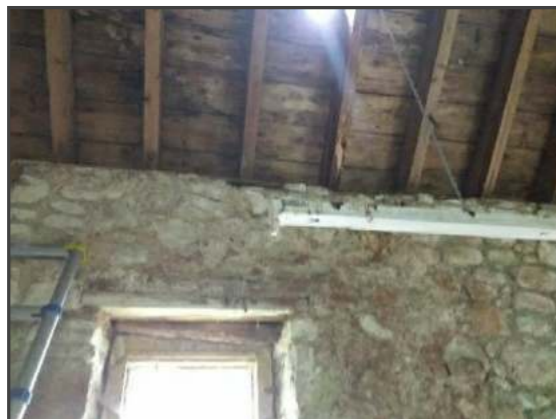
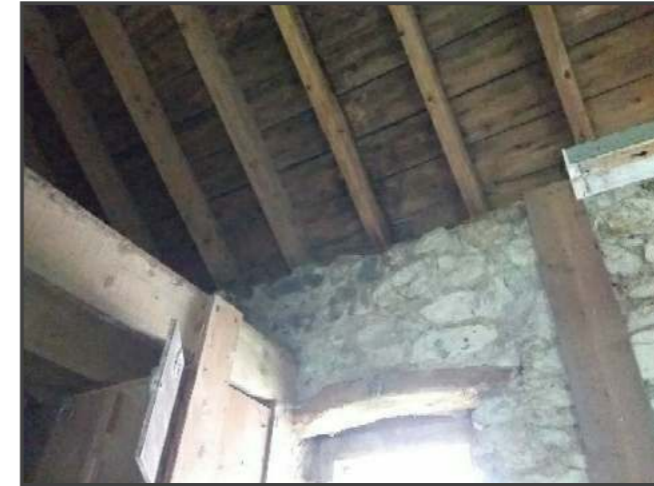
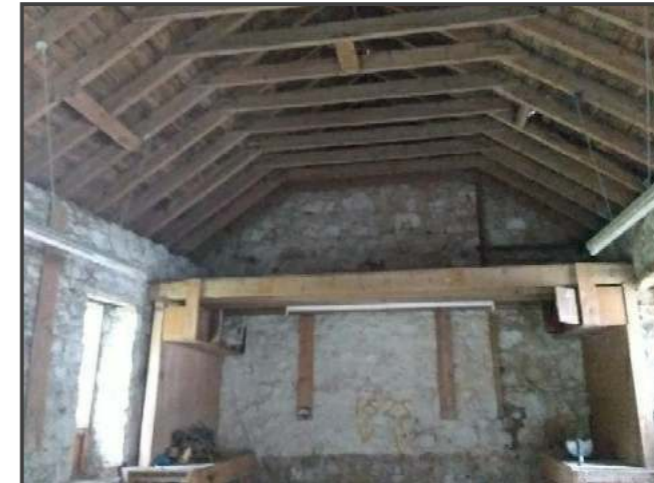
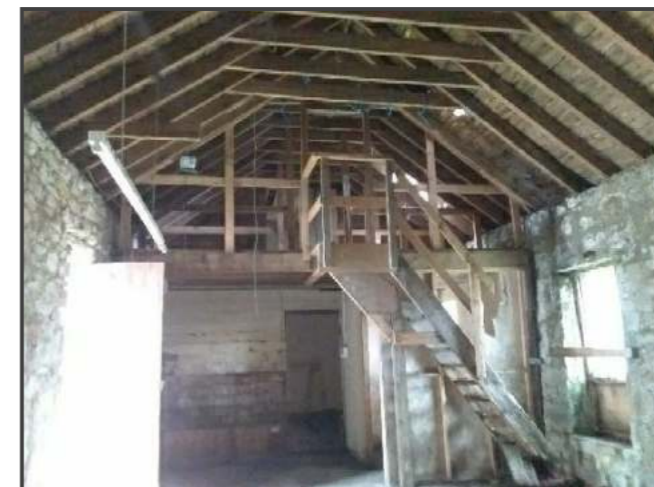
Nos 5 and 13 decay to rafter ends at front elevation.

Nos 18, 20, 21,22, 23,24,25,26,27 & 28 decay to rafter ends at rear elevation.

- Woodworm infestation was evident to timbers throughout.
- Severe woodworm and wet rot decay was evident to wallplates at front and rear elevations.

- Erect working scaffold/platform as required.
- Cut out affected wallplate sections and dispose of all debris.
- Install new treated timber wallplates duly wrapped in a damp proof membrane.
- Cut back affected rafter ends to sound timber and replace in similar treated timber with wall bearing ends dipped in fungicidal fluid and wrapped in a damp proof membrane and fixed to remaining sections with bolt on connectors.
- Cut out full length rafter and replace in similar treated with wall bearing end dipped in fungicidal fluid and wrapped in a damp proof membrane.
- All accessible exposed roof timber surfaces of remaining timbers are to be prepared and insecticidal / fungicidal fluid applied to all such exposed surfaces. This is a dual purpose application insecticide to deal with woodworm eradication and fungicidal fluid to preserve the timbers.
- Leave site clean and tidy.
