RIBA STAGE 2 REPORT

# 343 - INCHREE BARN

Project - Inchree Barn

Client - Nether Lochaber Community Association

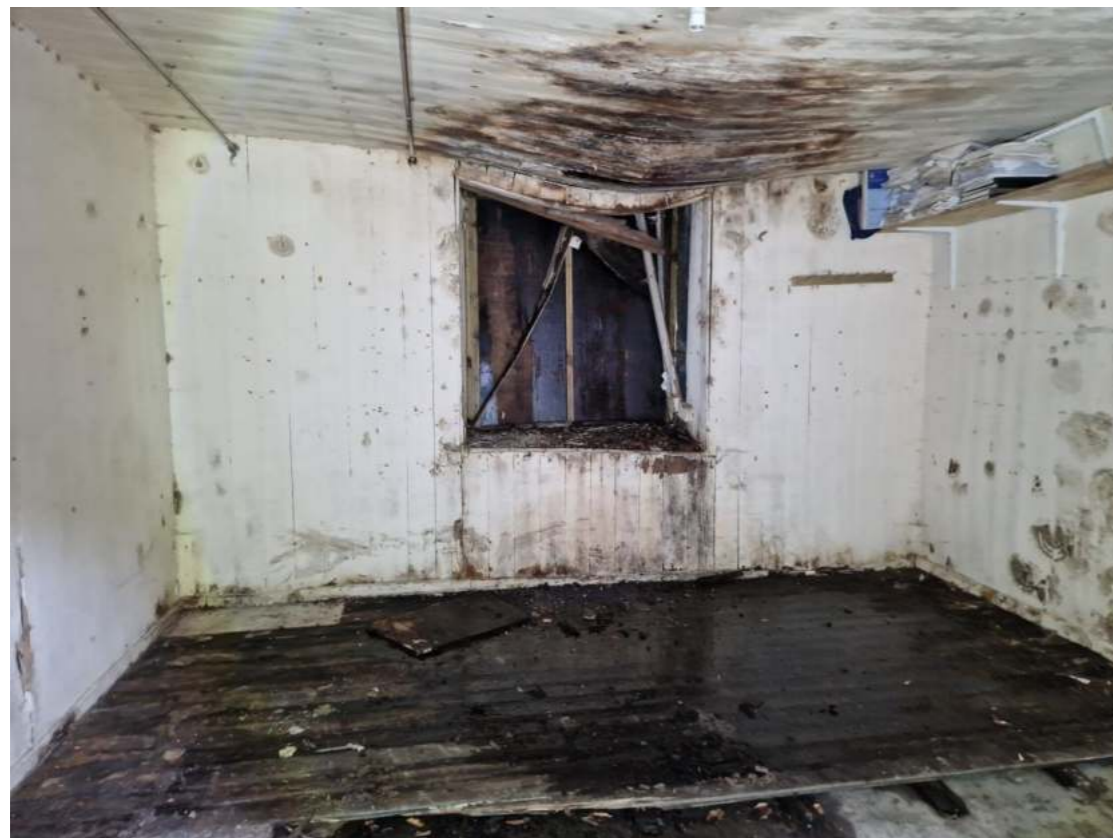
*Fig. 18 – An example of the interior water damage.*

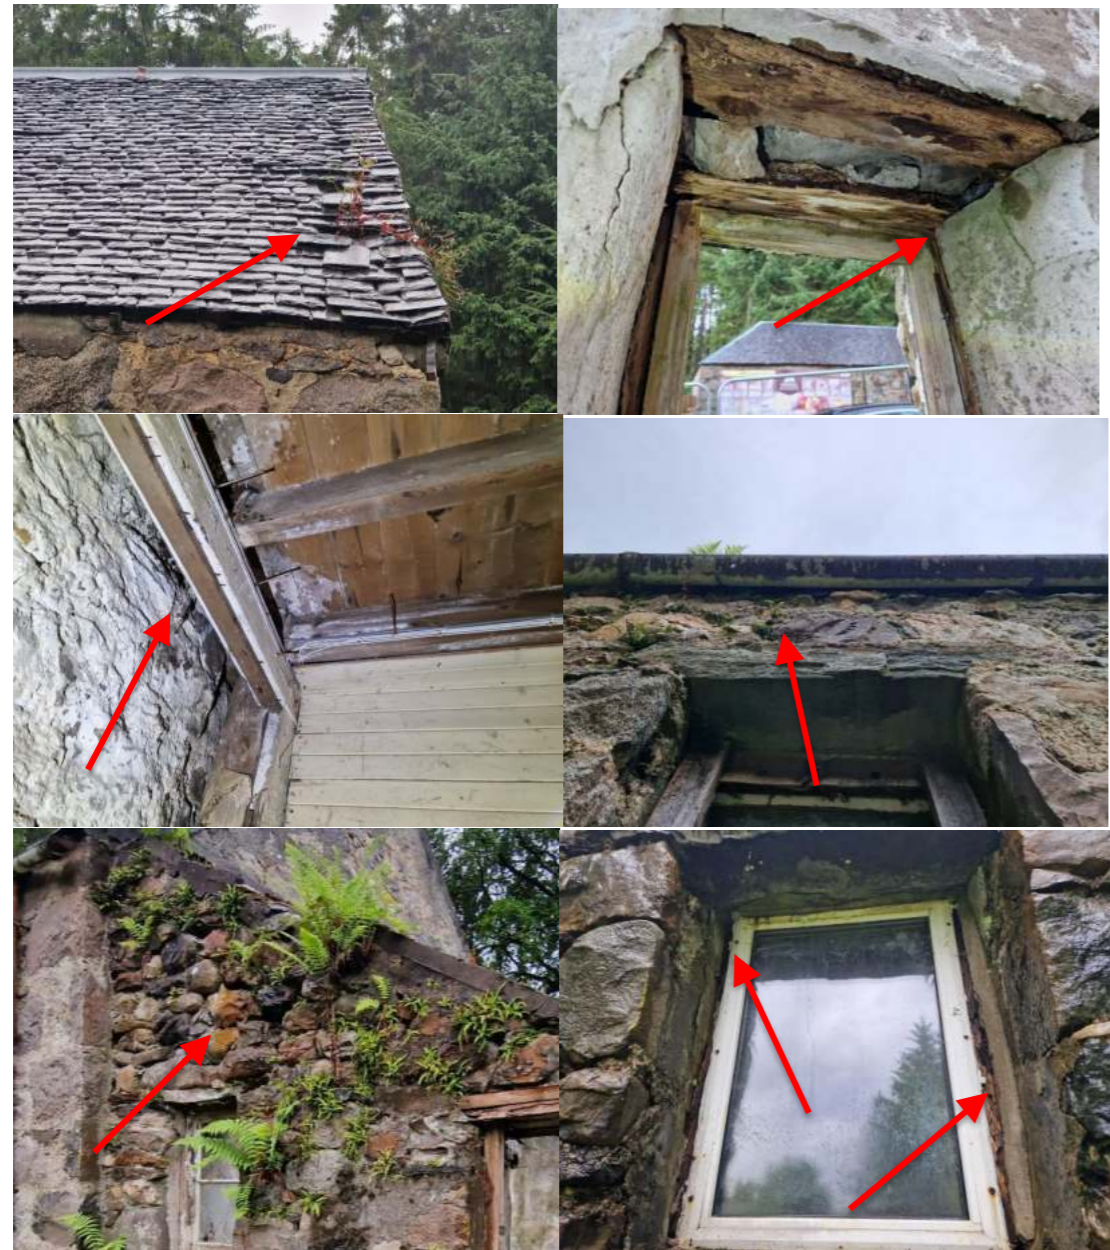
Fig. 21 – Potential roost features.
